FABRICATION AND VERIFICATION TESTING OF ETM 30 CM DIAMETER ION THRUSTERS

FINAL REPORT

APRIL 1977

ION PHYSICS DEPARTMENT STAFF
HUGHES RESEARCH LABORATORIES
A DIVISION OF HUGHES AIRCRAFT COMPANY
3011 MALIBU CANYON ROAD
MALIBU, CALIFORNIA 90265

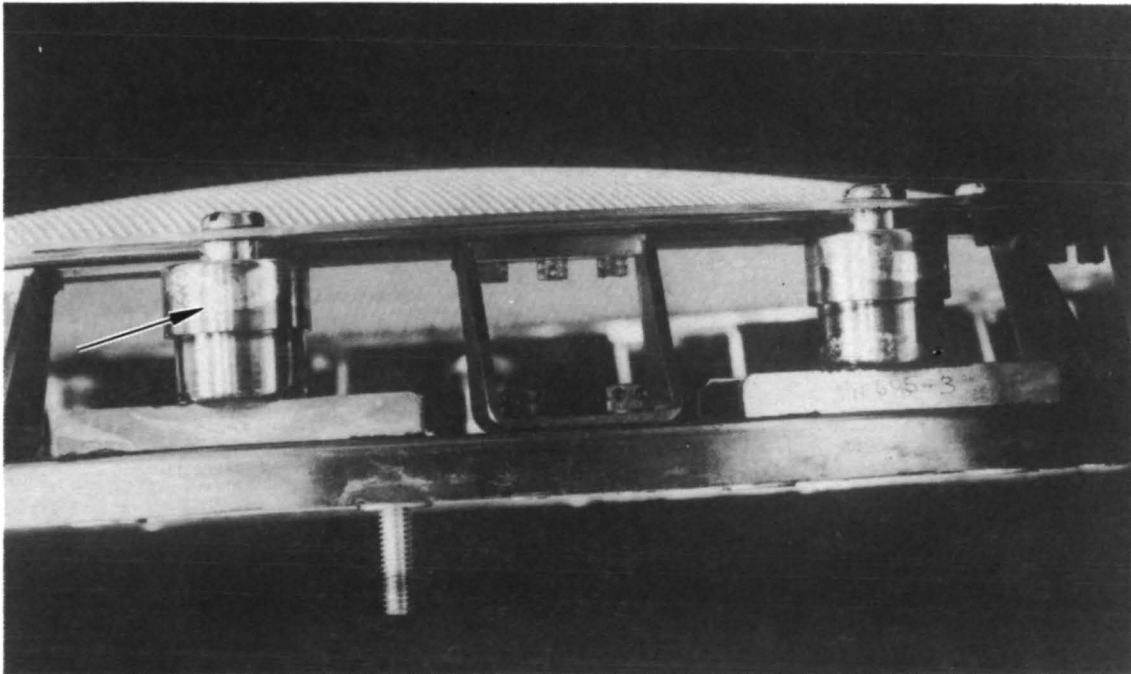
Figure A-98. Optics showing markings on insulator shields.

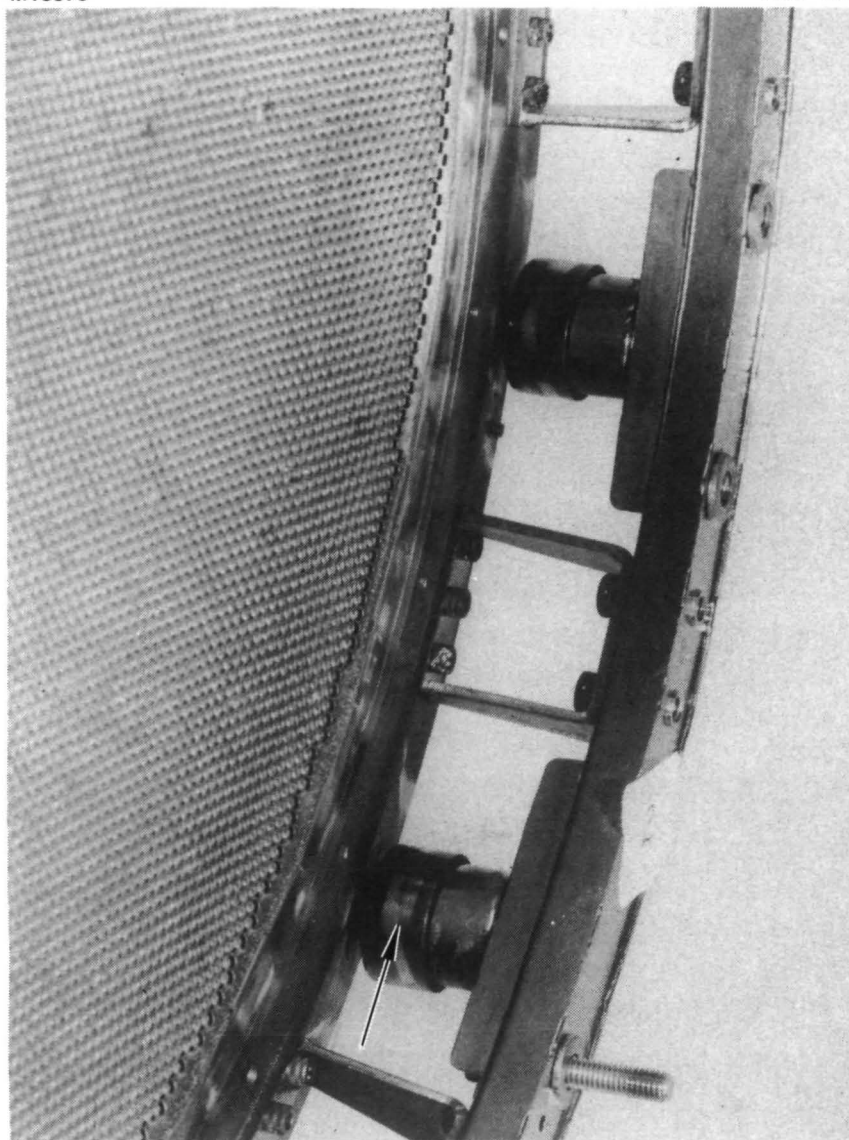
Figure A-99. Markings on optics insulator shields.

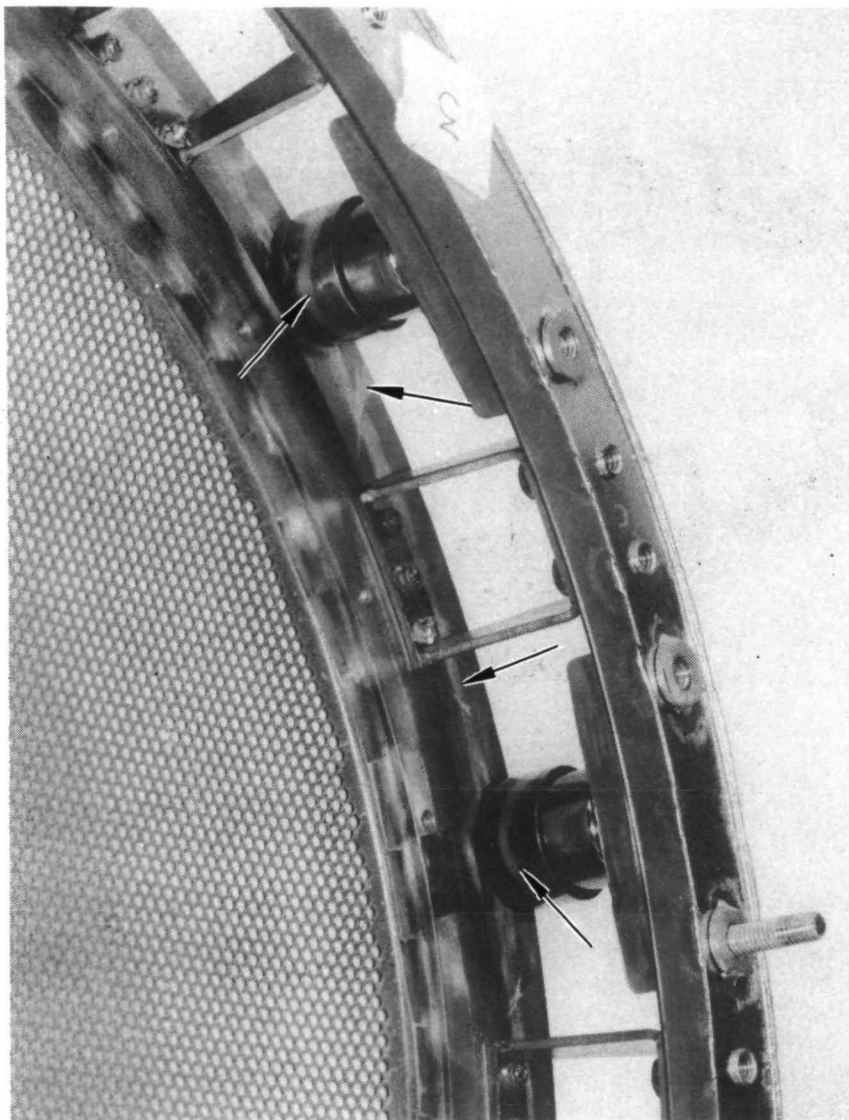
Figure A-100. Markings on optics insulator shields.

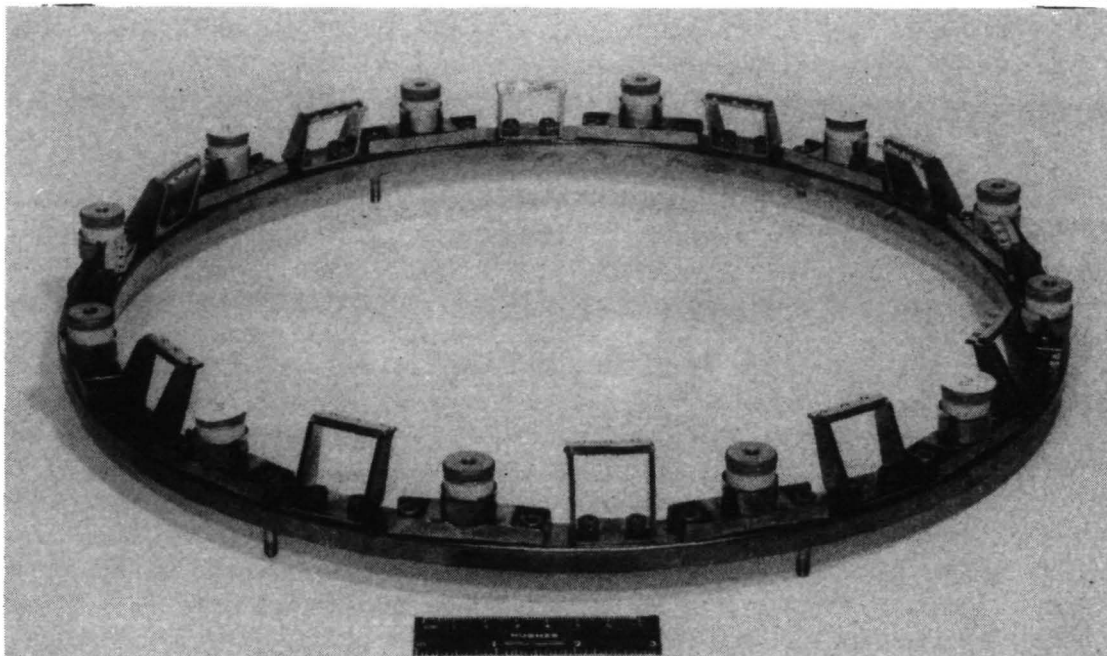
The final figure presented in this section shows the support assembly with the grids removed (see Fig. A-101). Note the pristine condition of the insulators. It would be impossible to differentiate this assembly from one that had been tested only a few hours.

Figure A-101. Optics support assembly.

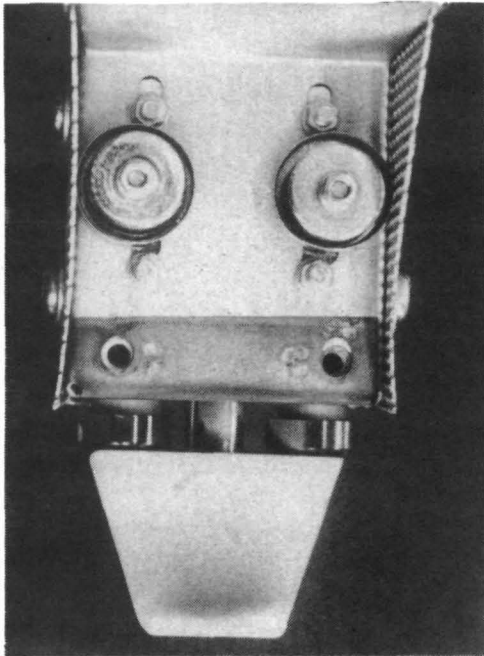
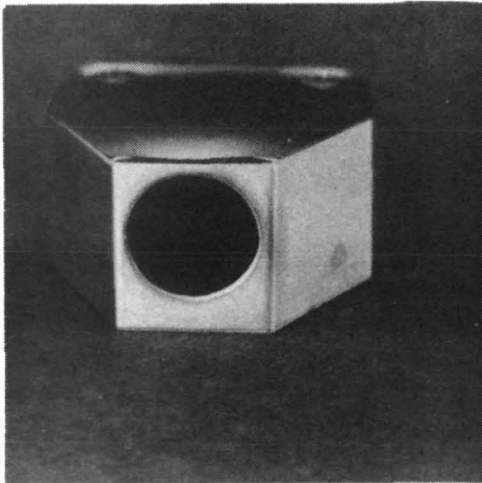
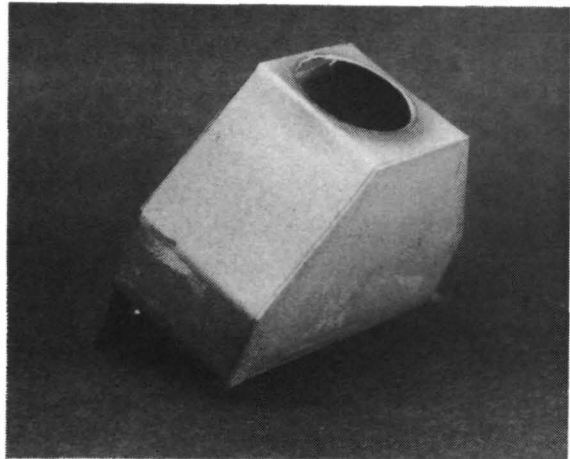
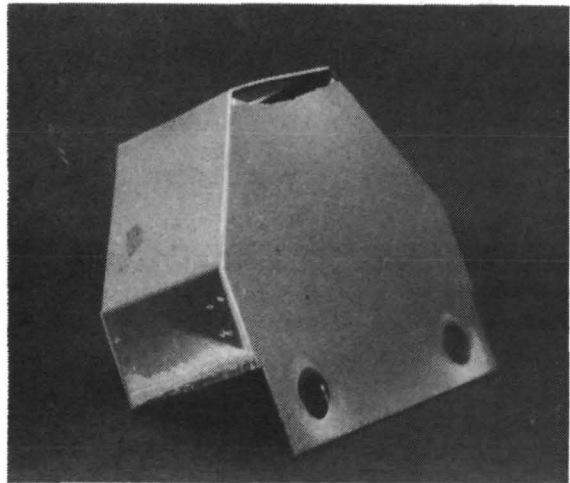
Figures A-102 and A-103 show the portions of the neutralizer SN 701 outer covering that is of interest here. Note that there is no evidence of deposition and that the keeper cover is in fact eroded away at the downstream most inboard surface. In contrast to this, Fig. A-104 shows that several surfaces of the neutralizer SN 415 outer cover are coated with both metallic deposits and finely divided mercury. Thus it appears that the active neutralizer is eroded while the inactive neutralizer has accumulated deposits. Figure A-105 compares dimensional parameters for the two neutralizers. Energetic ions with trajectories at angles up to 75° have been measured under the 2.5 kW Advanced Technology Ion Thruster Program (NAS 3-17831) and simulated by trajectory computations through variations in the shape of the neutralization plane. Consequently, it is concluded that the presence of erosion on the active neutralizer is related to the shape of the neutralization plane in the vicinity of the active neutralizer. A more definitive explanation would require further study of the observed high angle ion trajectories.

Figure A-102. Neutralizer 701 cover.

Figure A-103. Neutralizer 701 and keeper cover from neutralizer 701.

The neutralizer assembly, as examined here, is considered to have no major wear problems. Erosion of the keeper cover would be corrected most efficiently by eliminating or reducing the high angle trajectory ion flux. Otherwise, increasing the thickness of the cover would suffice to compensate for the erosion. Insulator deterioration can be readily eliminated by shielding of the exposed ceramic surfaces. Although the cathodes are discussed in detail in the following section, it is appropriate to note here that neutralizer cathode wear is relatively insignificant. Some operational anomalies observed during the test have resulted in a design change for the cathode insert, however.

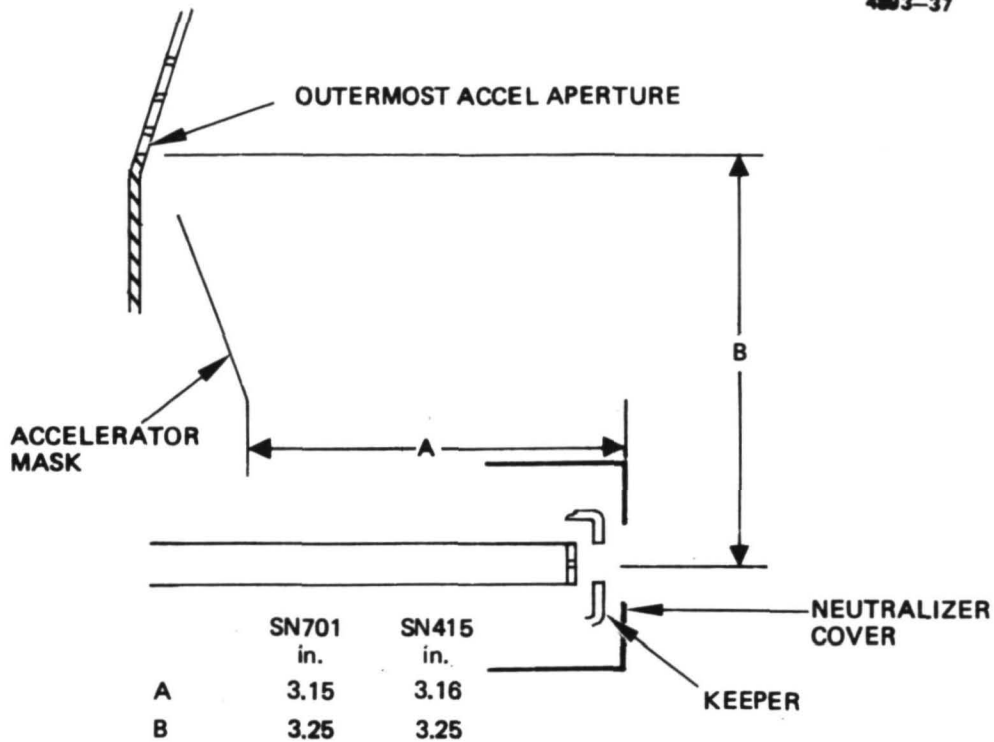
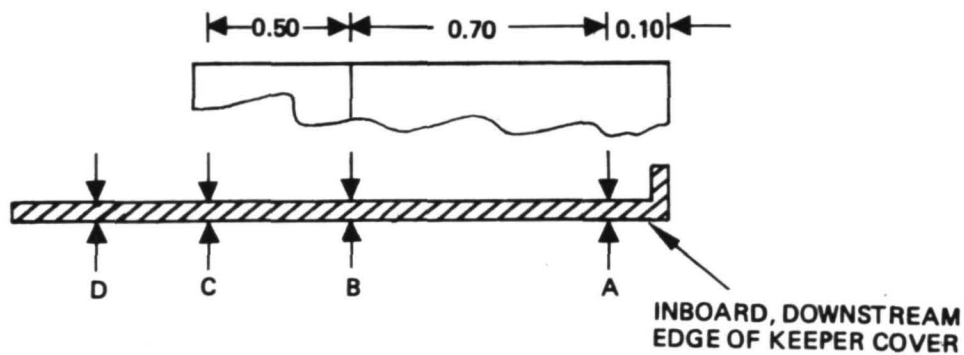
Figure A-105. Comparison of post test dimensions of neutralizers 701 and 415.

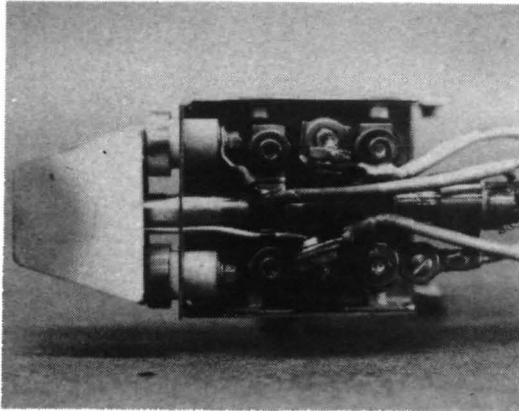
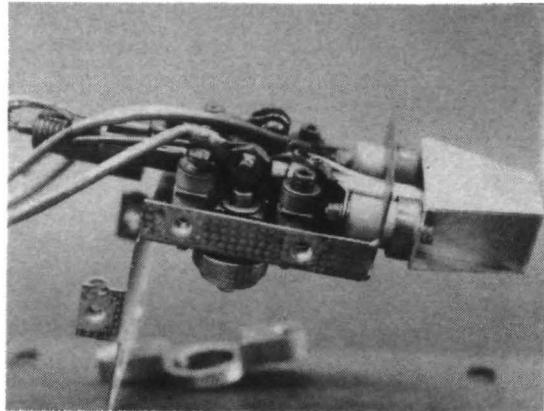
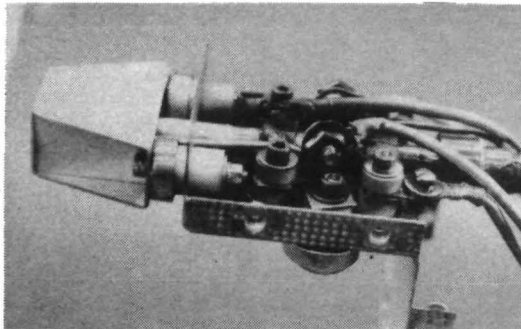
Figure A-108. Neutralizer 701.

Figure A-108 shows neutralizer SN 701 with the outer covering removed. Note the deterioration of the wiring and the discoloration of the insulators. Figure A-109 shows matching discoloration on both the interior and exterior surfaces of the outer covering parts. It is apparent that at least parts of the discoloration has its origin inside the neutralizer cover, and, based on the decomposition seen in the wiring, the wiring insulation is a probable source. Thus, future designs should make better provision for routing polyimide insulated wire such that high temperatures and consequently deterioration are avoided.

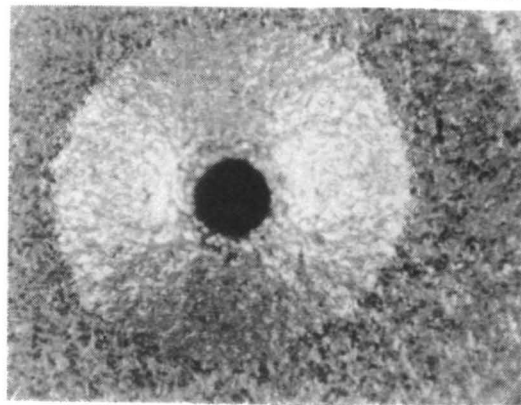
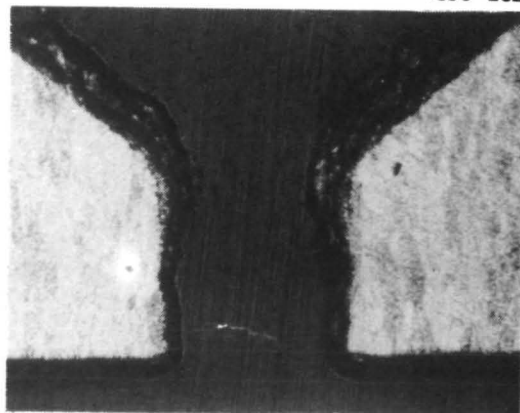
Figure A-111. Cathode radiator and orifice before and after test.

Cathode orifice dimensions govern the internal mercury vapor pressure for a given flow rate and thereby control the operational characteristics. Small changes in dimensions are tolerable and do not significantly affect the overall performance or operational characteristics of either the discharge chamber or the neutralizer. Measurement of the discharge cathode orifice using wire gauges shows that the orifice diameter decreased slightly from 0.028 in. (0.071 cm) before testing to 0.026 in. (0.066 cm) after the test. Figure A-111(a) through (d) compares photographs of the discharge cathode orifice and radiator taken before and after the test in views (a) through (d). It is apparent that the surfaces of the cathode and radiator have been eroded by ion sputtering. Cross sections of the cathode shown in Fig. A-111(e) and (f) indicate that the material removed is negligible. Figure A-111(f) shows evidence of a coating in the orifice region. The erosion seen is not considered

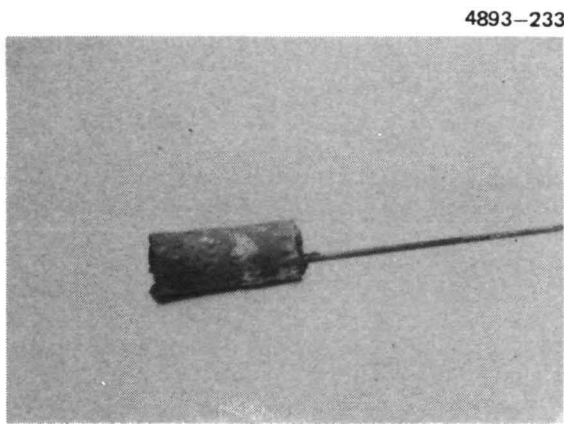
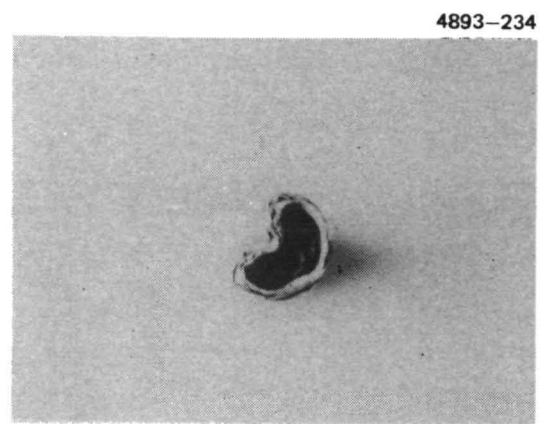
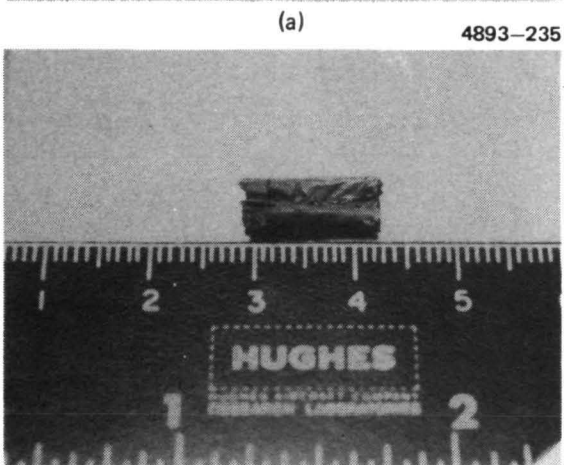
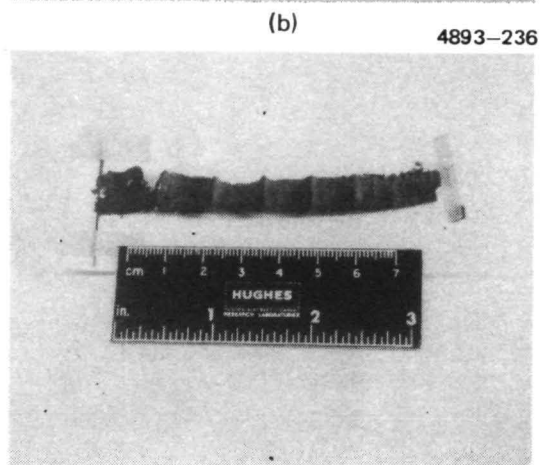
Figure A-113. Discharge cathode insert.

condition, although the powdery coating, thought to be the triple carbonate (or oxide) material, was extremely fragile and brushed off quite easily. The discharge cathode insert is shown in Fig. A-113 as it appeared on removal and after it was unrolled. The most in downstream edge of the insert appeared "fused" and broke off during the unrolling process. The insert material was neither extremely brittle nor ductile but was "springy" and caution was required to prevent the foil from rolling up again. The weight of the insert was 0.359 g after the test as compared to the initial weight of 0.401 g. No attempt has been made to analyze this weight loss (42 mg) since a whitish, powdery coating, presumed to be a portion of the emissive coating material is found inside the cathode and on the downstream surface of the C-IV flange (see Figs. A-114 and A-115). Moreover, the foil insert design has been replaced by a barium aluminate impregnated porous tungsten material in 800-series thruster designs. This change has been made to improve the quality control and operational control of the neutralizer. Thus, the results of further quantitative analysis relating to the foil design are considered relatively unimportant.

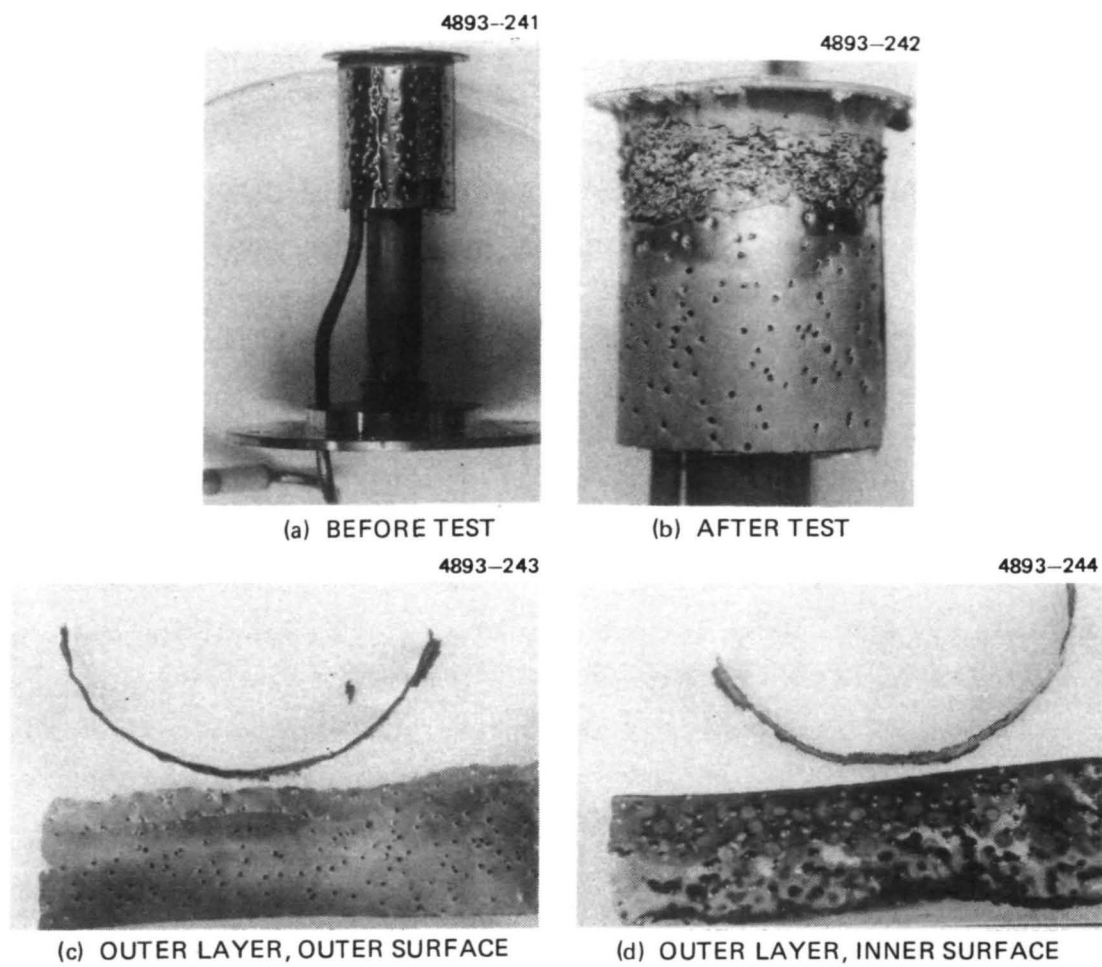
Figure A-117. Cathode heat shield before and after endurance test.

The discharge cathode requires heat shielding to enable the cathode to reach emissive temperature, primarily because the alumina bond between the heater coil and the cathode tube does not provide adequate thermal contact. As pointed out earlier, this heat shield was partially eroded by ion sputtering. It is thought that this ion sputtering is a consequence of operating with a damaged baffle, which permitted high-energy discharge ions to enter the cathode pole region. Figure A-117 shows the extent of the erosion of the heat shield. Three of the five layers have been penetrated (see Fig. A-118), and, if this type of erosion were continuous, the heat shield could probably furnish another 5000 hours of operation without difficulty. Figure A-119 shows the cathode heater with heat shields removed and compares the insulator as seen before and after testing. Notice that although the ceramic material is cracked, there is no loss of material or insulation between heater windings.

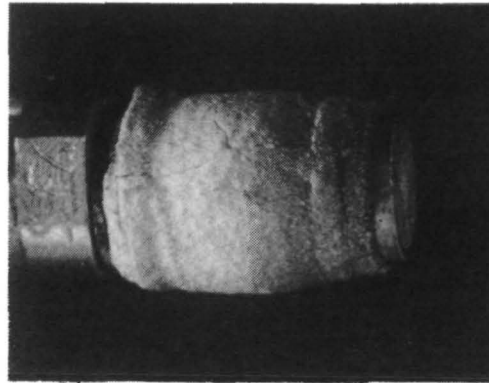
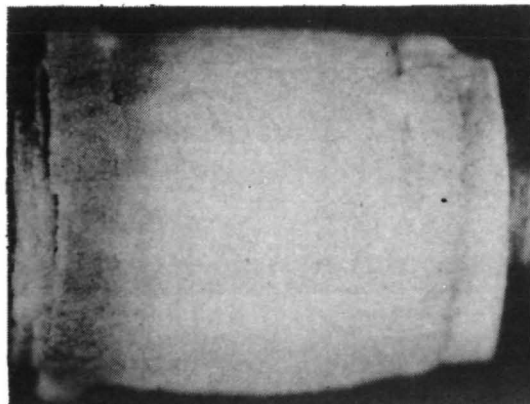
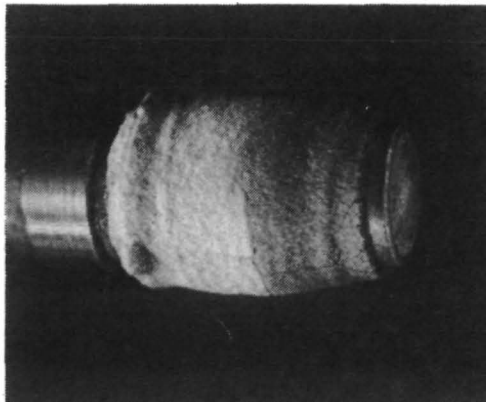
Figure A-120. Neutralizer 701 tip heater before and after endurance test.

The neutralizer heater is shown in Fig. A-120 as seen before and after the test. Note that the cracks seen in the ceramic coating were present even before the test and the many cycles of start-up only increased the cracking somewhat. Both of these heaters performed excellently during the 10,000 hour test, without any change in power requirements.

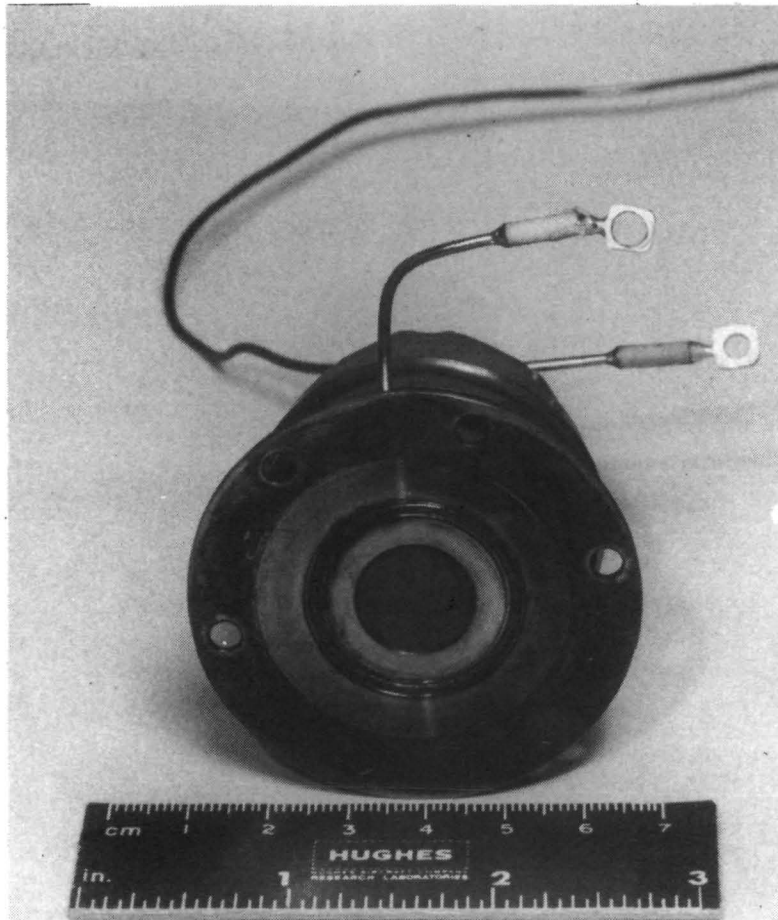
Figure A-127. MIV after endurance test.

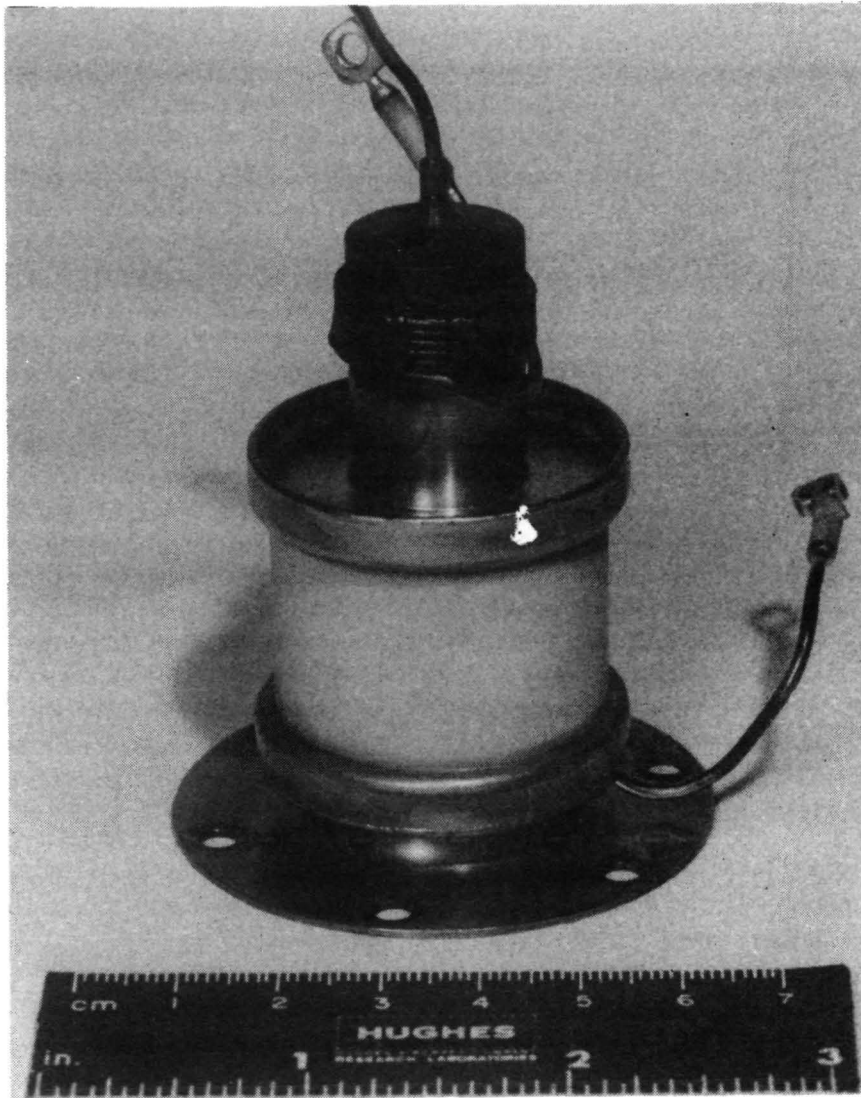
Figure A-128. MIV after endurance test.
